Preservation Project for the Enryakuji Konpon Chūdō (National Treasure) and Konpon Chūdō Cloisters (Important Cultural Property)

Owner: Enryakuji Temple
Location: Sakamoto Hon-machi, Otsu City, Shiga Prefecture
Repairs policy: Re-roofing and paint repairs
Project period: 1 April 2016 to 30 September 2030
Project costs: Approximately 7.3 billion JPY
(subsidies from the state, Shiga Prefecture, and Otsu City)
Outline of structures
(1) Name/Designated classification
Enryakuji Konpon Chūdō: (National Treasure)
Enryakuji Konpon Chūdō Cloisters: (Important Cultural Property)

Restoration policy

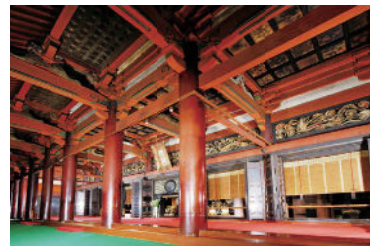
Konpon Chūdō interior
(middle, outer sanctums)

The painting in the middle and outer sanctums, and the black lacquer, coloration and fittings for the three shrines in the inner sanctum are to be restored.

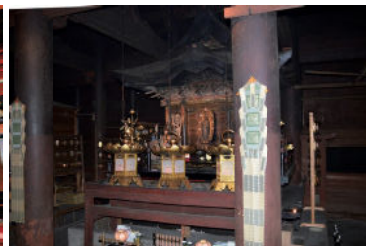
Zushi shrine in the inner sanctum

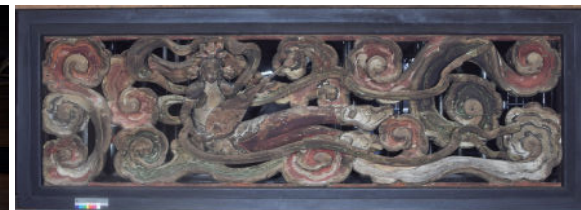
Transom along the inner and middle sanctums' boundary

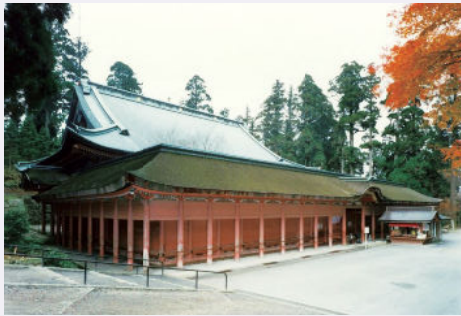
Photo before this current restoration

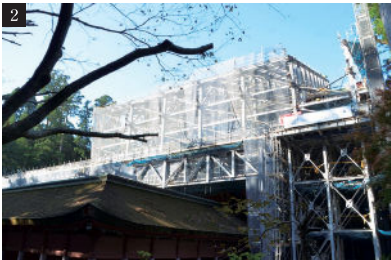
1) Assembly of the first steel skeleton

Before work on Konpon Chūdō could begin, scaffolding had to be constructed to protect the structure from the elements and provide a working platform for the restoration crews. This initial step took approximately two years. Given the limited open space around Konpon Chūdō, the temporary roof and scaffolding were assembled using an accumulative sliding method. Eleven steel frames each measuring over 5 meters long were assembled on a platform on the northern side of the main hall. Then, each frame was slid into place with a hydraulic jack. The process was repeated for each frame until the entire hall was covered. A viewing platform was built on the east side of the scaffolding to give visitors an up-close look behind the scenes at the traditional techniques used by the people working on the restoration.

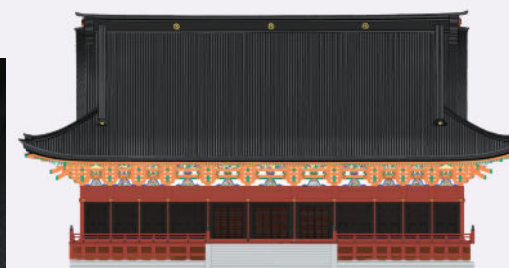
From left: the late 18th century, the late 19th century, and the mid-20th century (two types)

Some copper plates used from the late 18th century showed traces of black paint. The scientific analysis detected pine resin contained in the chian turpentine. From this, it appears that black chian was applied when the roof was changed from shingles to copper in the late 18th century. This current restoration uses black chian on the copper, restoring the mid-Edo appearance.

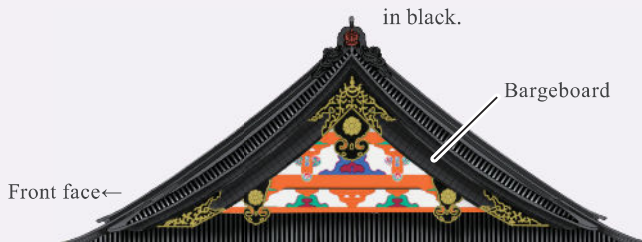
Black coating on bargeboard copper plates

The copper plates on the north gable bargeboard were flipped over and reused when the bargeboard was repaired in 1798. The black paint remaining on what is today the underside dates back to the mid-18th century, so it is probably the “black plate” finish referred to in the old texts. The black paint on the surface dates to the late 18th century, and is known to be chian as analysis has detected pine resin in it.

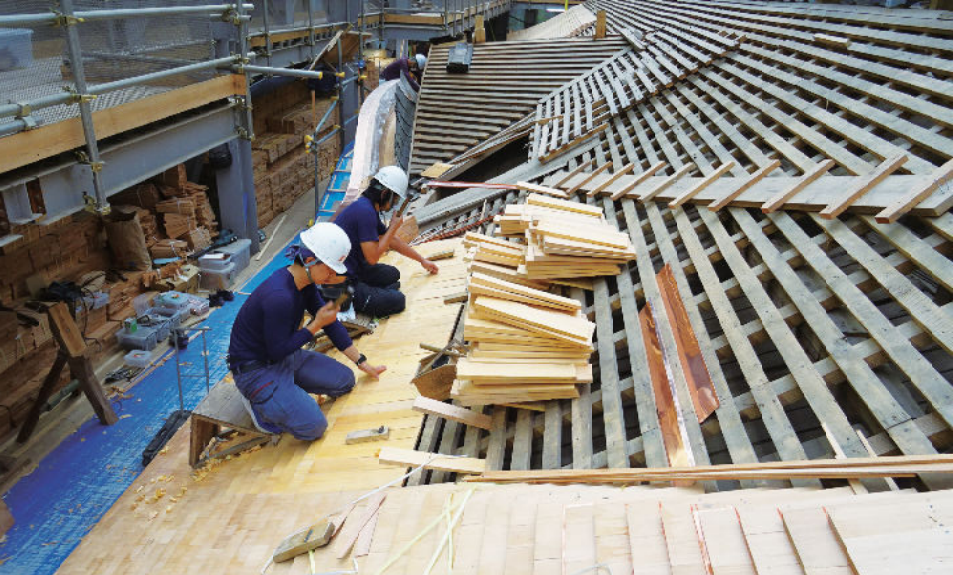
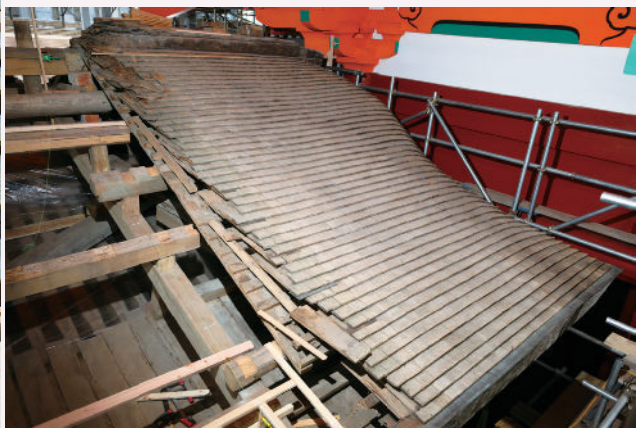
The shingles believed to be from the Edo period that remain on the north and south sides of the cloister

The corridor's roof is covered with shakes, a type of wood shingle made by splitting the wood along the grain. The kind used here is called *tochi-ita* in Japanese. Over 100,000 *tochi-ita* shakes cover the 1,000-square-meters of the corridor roof. The shakes began to rot or deteriorate from exposure to wind, snow, and rain over the 60 years since the last restoration of Konpon Chūdō.

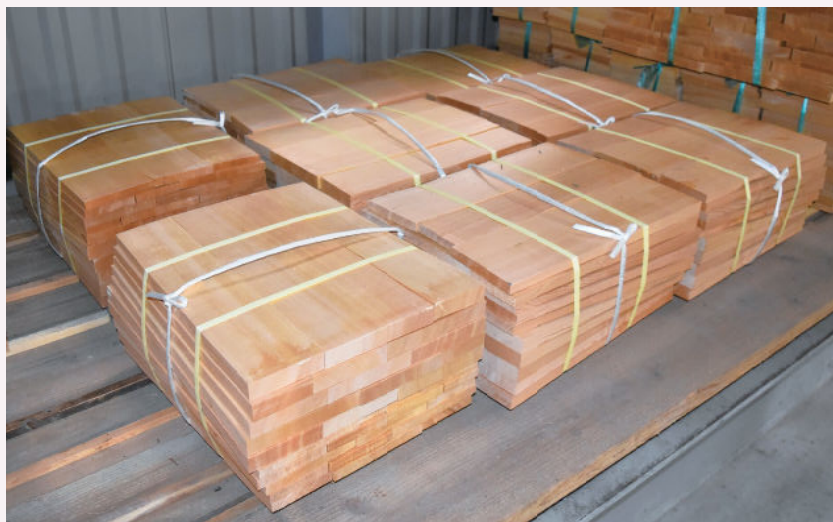
In this restoration, the shingles believed to be from the Edo period that remain on the north and south sides of the cloister have been preserved.

The shingles are made from *sawara* cypress wood. *Sawara* cypress is easily workable and water-resistant, so it has long been valuable as a roofing material. However, it is not as easy to obtain these days.

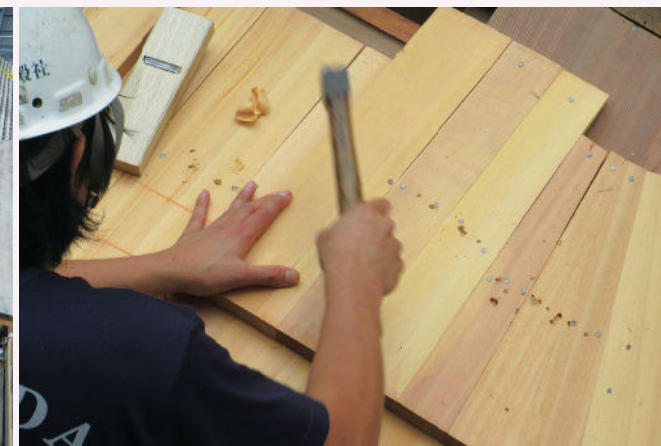
Making thick shingles (*tochi-ita*)

To make a shingle, the cypress log is cut into rings, each of which is split into six parts. Each part is then split multiple times by hand to an appropriate thickness.

They are then split to the required thickness, and planed with a blade diagonally.

Doing this by hand means that the cypress is split along the fibers, leaving tiny fluctuations on the surface. These mean that air can still circulate even when they are layered, helping the wood to last.

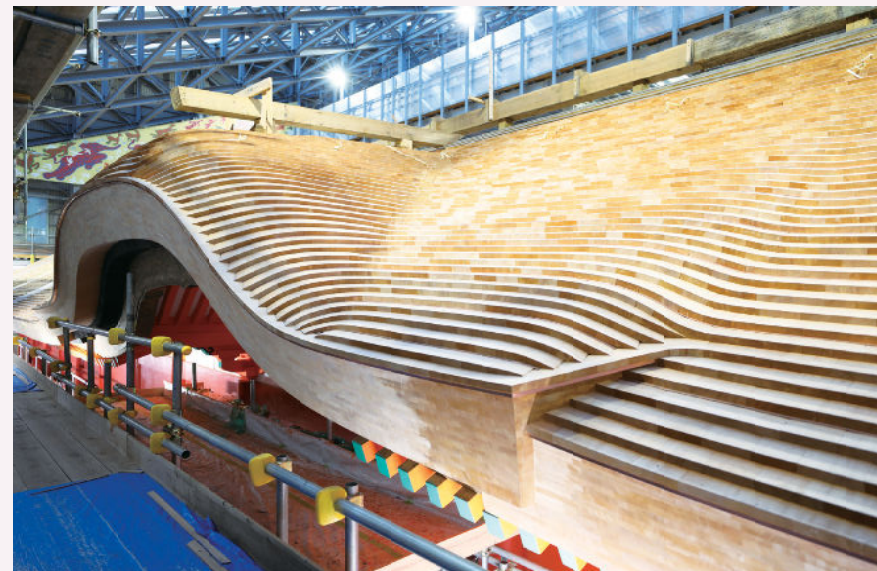
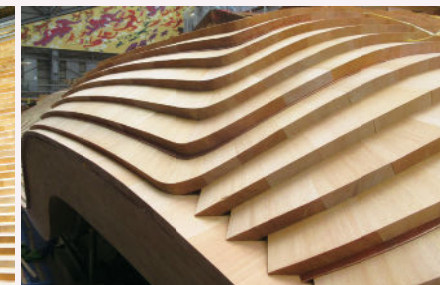
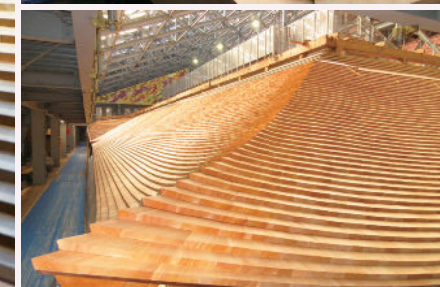
The shingles, 45 cm long and 2.4 cm thick, are staggered at 8.5 cm intervals and fastened with bamboo nails. Our predecessors skillfully adapted their techniques to suit the humid environment around Konpon Chūdō. Repair Manifests from the mid-17th century onwards record that thinly-shaved shingles were inserted between the joints of the thick shingles. This is a way to ensure air circulation by ensuring shingles are not too close together. In repairs from the early 20th century onwards, copper plates were wedged in amongst the shingles. Copper leaches ions when exposed to water, which flow over the surface and help protect the wood from rot.

The gate in the middle of the cloister has a curved roof, so the shingles need to be shaped on site in order to fit properly. Similarly, the corners, where the cloister changes direction, need to be shingled so the shingle lines are continuous.

As copper plates were inserted in the previous restoration, and the underlayment over which the shingles were attached was in good condition, copper plates are being used in this restoration as well.

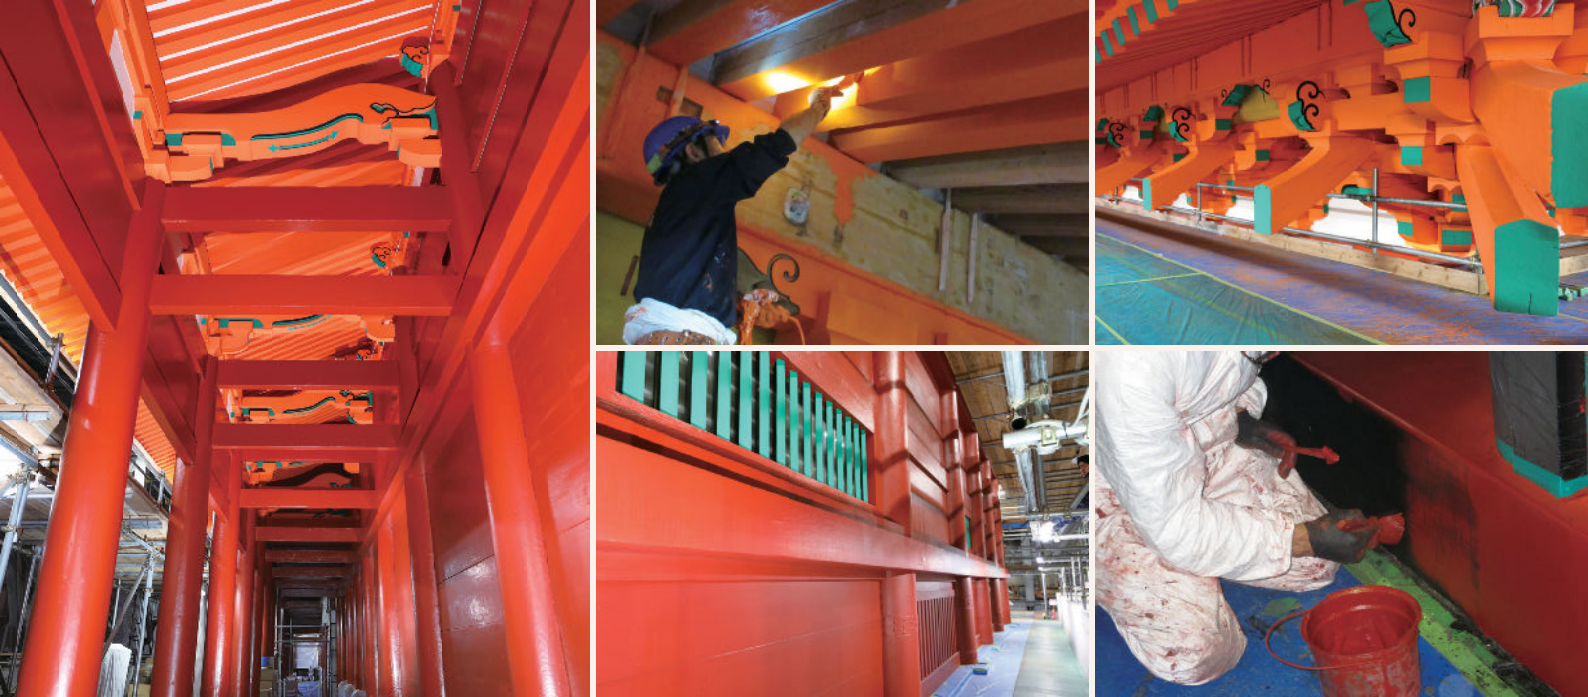
TOP: *Tan-nuri* BOTTOM: *chian*

The exterior painting on Konpon Chūdō and its cloister is being entirely redone. Investigations have shown that different techniques and colors were used for the top and bottom. The area around the eaves was done in orange using vermillion lacquering (*Tan-nuri*), while the walls were done in deep red using *chian*. This restoration recreated the mid-18th century two-tone upper and lower coloring.

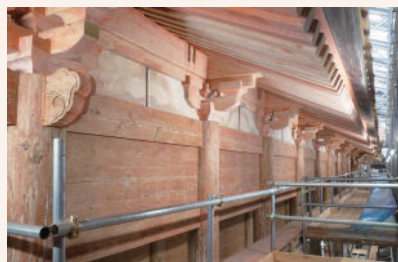
With the paint stripped

The eaves and walls can be seen to have different shades of red.

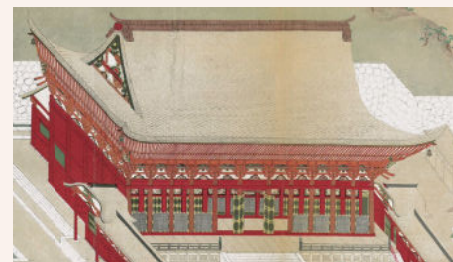
An old illustration that shows what is thought to be Konpon Chūdō shortly after its completion shows the eaves as orange and the walls as deep red, which matches with the analysis results and Repair Manifests.

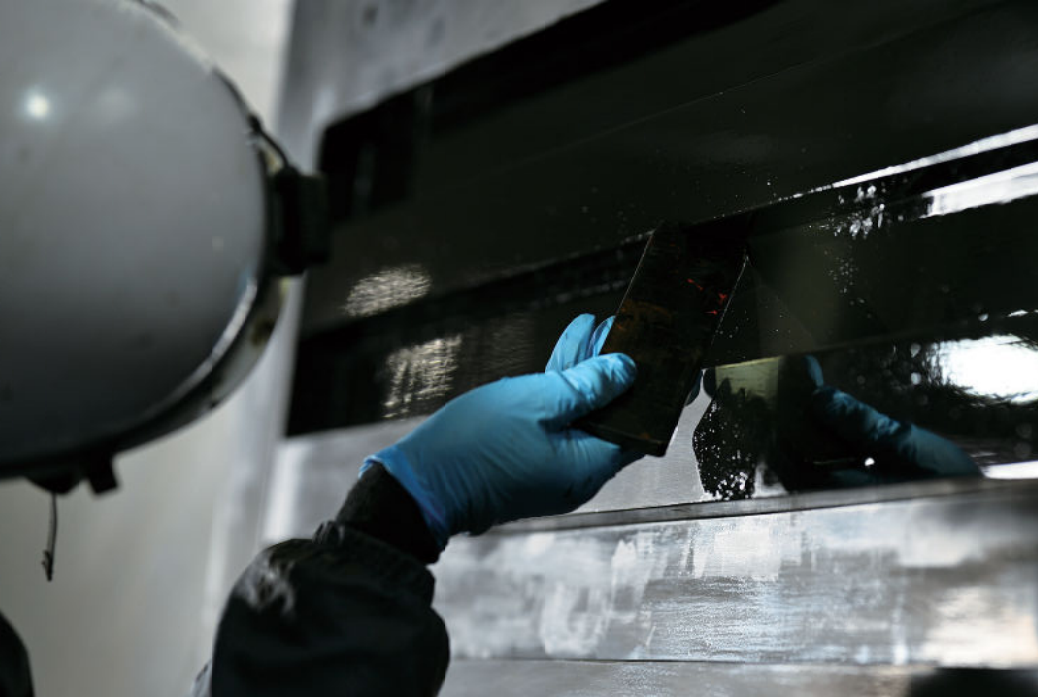
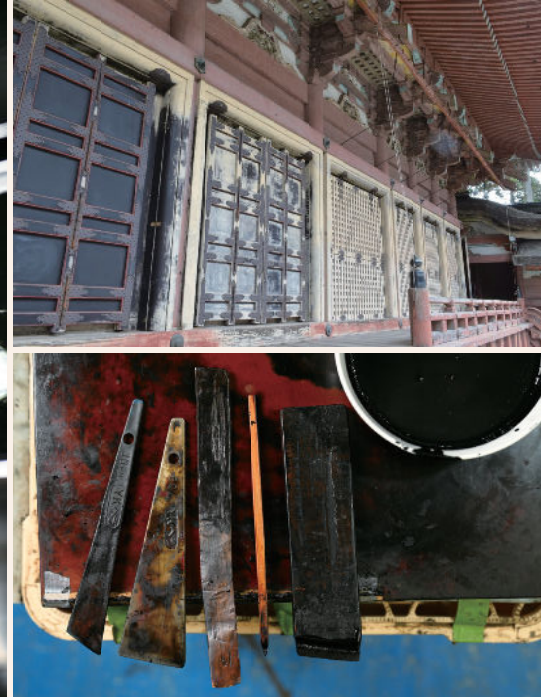
TOP: Damaged fitting prior to restoration
BOTTOM: Tools for lacquering

The fittings in Konpon Chūdō are coated in black lacquer. These are being recoated, as the old lacquer was becoming powder or peeling.

Lacquering requires multiple undercoats to create a smooth surface. The surface must be very smooth, because the viscous lacquer will bring out every little bump and dip.

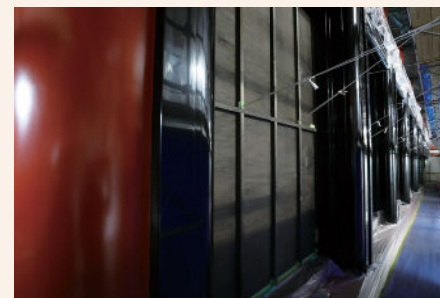
The black lacquer in the area around where the fitting goes is redone

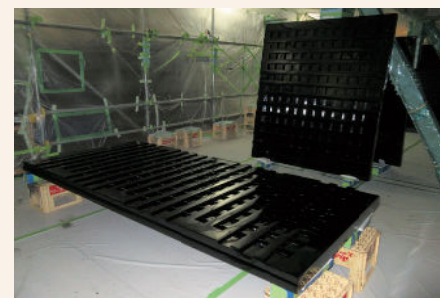
The fittings that have been lacquered

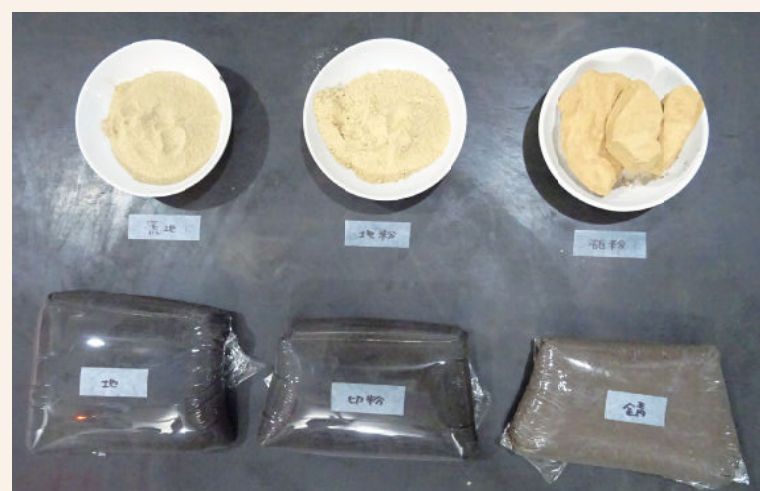
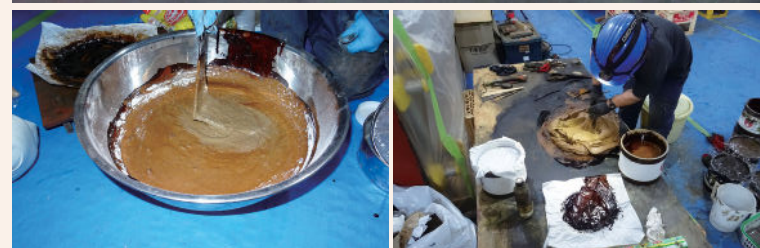
TOP of left pictures:
The undercoats are a blend of fine-grained earth and lacquer. The higher the layer, the finer the earth used.

LOWER LEFT of left pictures:
Undercoat made using a blend of rice glue, lacquer, cotton, flour, and *keyaki* sawdust

LOWER RIGHT of left pictures:
Making the undercoat

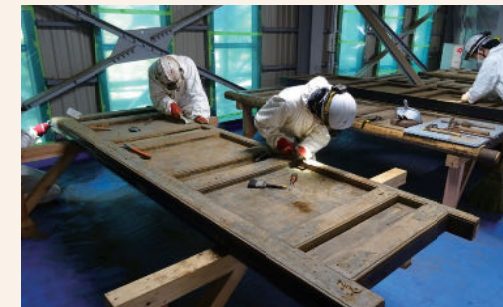
① The old damaged coating is removed by hand using chisels. Areas in good condition are kept.

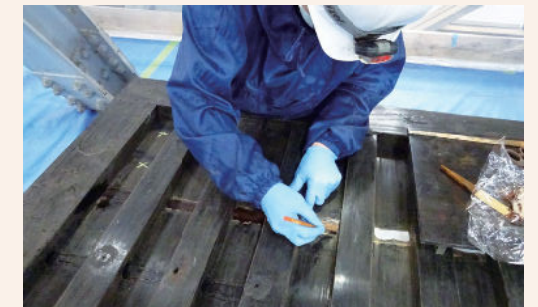
② Areas that are notably uneven or likely to split have hemp cloth pasted over them to soak in the undercoat.

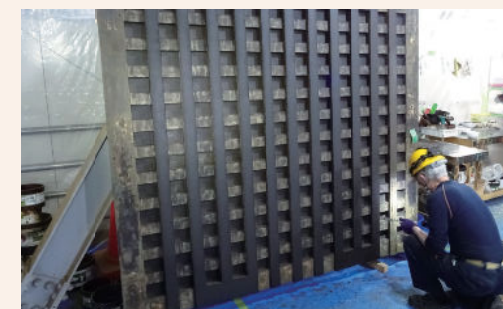
③ The layers of undercoat start with the coarser levels and gradually get finer.

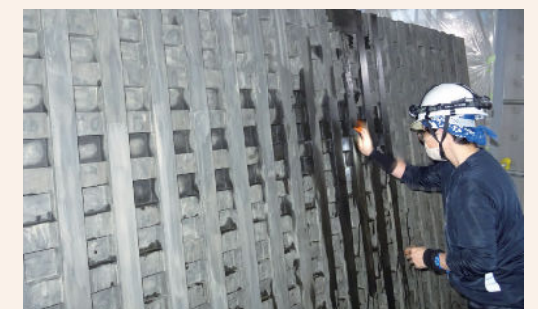
④ After undercoating, it is sanded smooth.

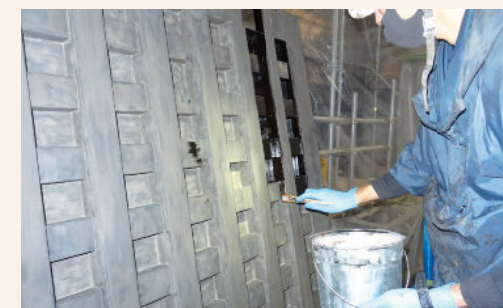
⑤ After sanding, lacquer is applied to strengthen the surface.

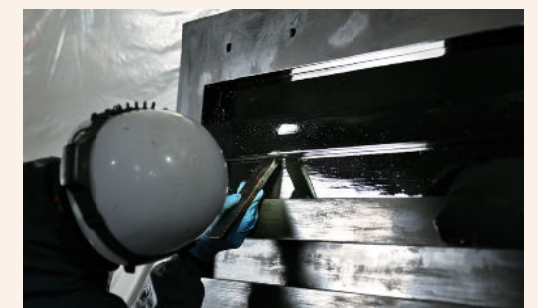
⑥ On top of the undercoats that have been layered up to this point, lacquer is applied to strengthen the finishing coats of lacquer. Four coats were used in this restoration.

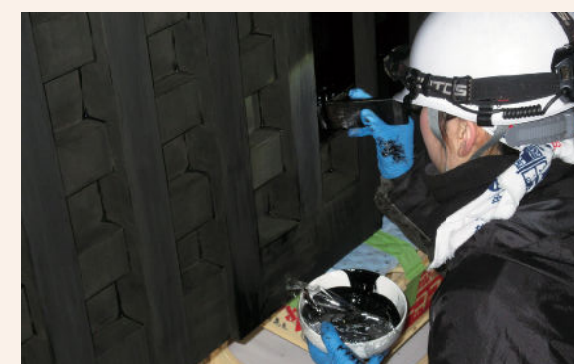
⑦ The workplace is cleaned, then the top coats of lacquer are applied. Lacquer hardens by reacting with moisture in the air, but as humidity is always high around Enryakuji, work is done with an eye on the weather to prevent condensation from forming. It took about a year from removal to the final coat.

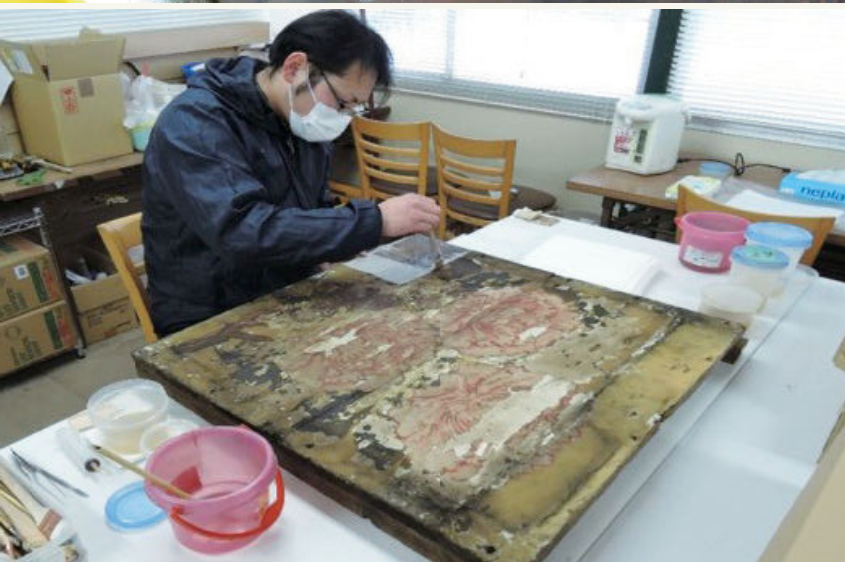
Cleaning and pigment-fixing work

The ceilings in Konpon Chūdō and cloisters are decorated with paintings. There are 200 in Konpon Chūdō and 48 in the cloisters. These paintings are dirty with soot and missing pigment, but precious coloration still remains.

During this restoration, all the ceiling paintings were removed, cleaned, and treated to fix old pigment in place.

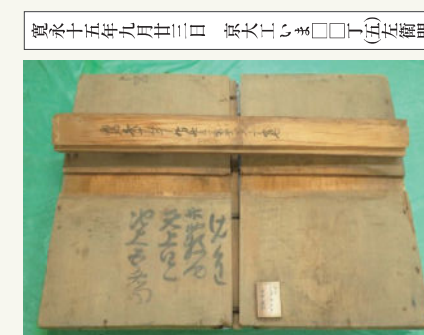
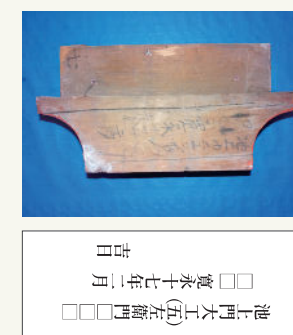
The ceiling paintings along the cloisters have suffered much loss of pigment, and only a few have traces of the picture. However, they are still valuable, as they are extant examples of the Kano School, Japan's largest school of painting, which flourished from the 15th to 19th centuries.

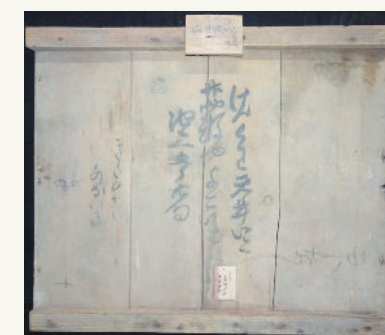
The ceiling panels are formed from two flat panels, with crosspieces on the upper side. One of these crosspieces has the name “Gozaemon” and the date written in black ink. This may well be the same person as the man in the “Ikegami Gozaemon” ink calligraphy found in Konpon Chūdō. The Ikegami family were noted carpenters in Kyoto, and helped build Konpon Chūdō. This suggests that the ceiling panels are from when it was first built.

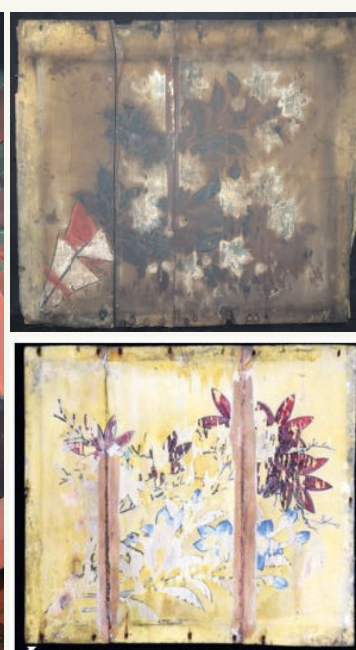
They depict flowers and grasses from Japan. The ceiling paintings in Konpon Chūdō and the cloisters share themes and methods. They are thought, based on Repair Manifests, to date from 1752.

LEFT: Ceiling paintings in Konpon Chūdō
UPPER RIGHT: Bellflowers (Konpon Chūdō)
LOWER RIGHT: Maple Leaves and Bellflowers (cloisters)

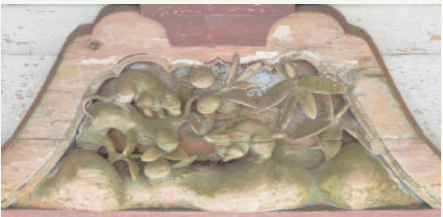
The Konpon Chūdō and cloisters have carved frog-leg struts. There are 34 in the Chūdō, all of which feature animals. As well as real animals, there are imaginary ones like the Chinese qilin. The middle of the front side features cranes and tortoises, which are considered good luck in Japan.

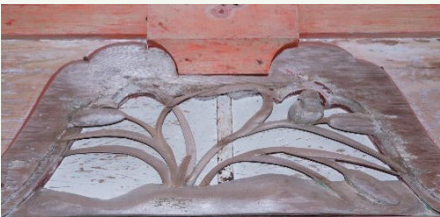
There are 78 in the cloisters, most of which are combinations of birds and plants. They feature familiar plants and animals to give a feeling of rural hills or coasts. Unlike the animals in the Chūdō, which protect the sacred zone, the cloisters appear to reflect the secular world.

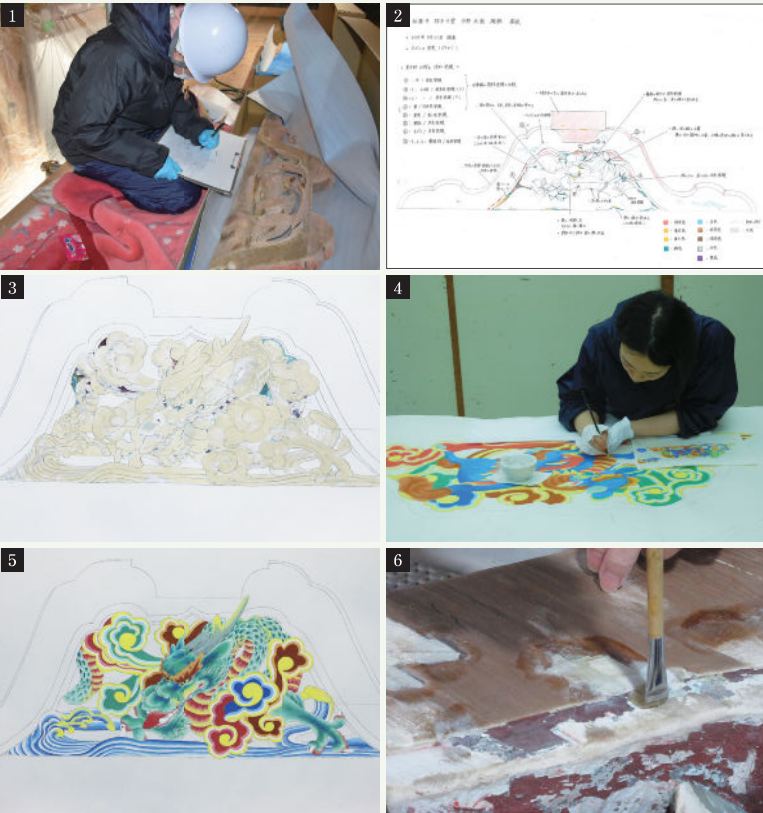
Color restoration process

In this restoration, the colors remaining on the carvings were investigated and recorded, and drawings were created based on this. Pigments remaining on the carvings were covered with extremely thin washi stuck down with nikawa water to protect them. Then the color was applied based on the drawings.

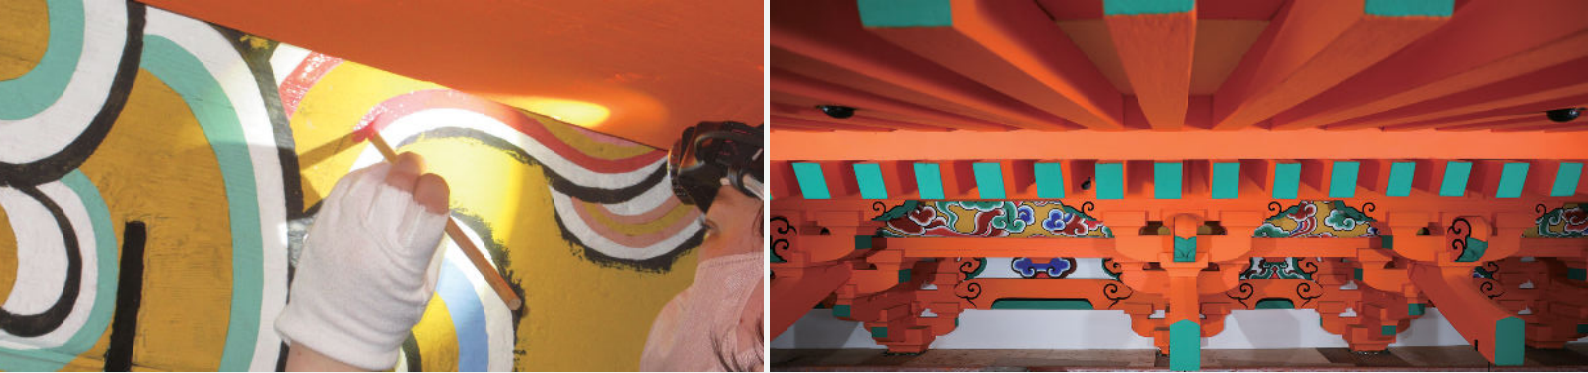
Tiny amounts of two-layered pigment remain on the struts. The bottom layer dates back to the original construction. It was a painted layer, with paint applied over gold leaf. There are still trace amounts of blue mineral pigment on the legs, and vermilion from mercury on the carved moldings. The 1752 Repair Manifest records that the frog-leg strut colors were redone, so the top layer of pigment can be dated to this time. The top layer is done using blue from smalt for the legs and red from bengara on the carved moldings. Smalt is an artificial blue pigment made by coloring glass with cobalt. It was first used around the 18th century. Bengara also started to be produced on an industrial scale then. The mid-18th century restoration retained the color expressions from the original designs while actively incorporating these new pigments.

LEFT: Parent and child civets, pomegranates CENTER: Fowls and larch tree RIGHT: Qilin and clouds

Konpon Chūdō is decorated with bright colors over a variety of delicate designs. Restoration of the colors was based on drawings made from investigations of the colors remaining on the carvings. First, the remaining pigments were treated to ensure they did not flake off anymore, then the colors were recreated.

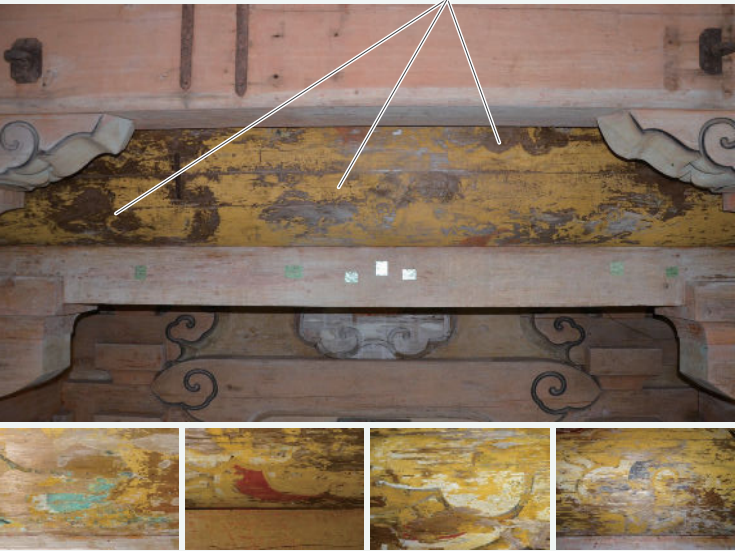
Traces of paint from top layer Outline of undulations (clouds)

From left: Green from *ryokusho* (a green pigment made by pulverizing malachite), Red-brown from *bengara*, Blue, Vermilion from mercury

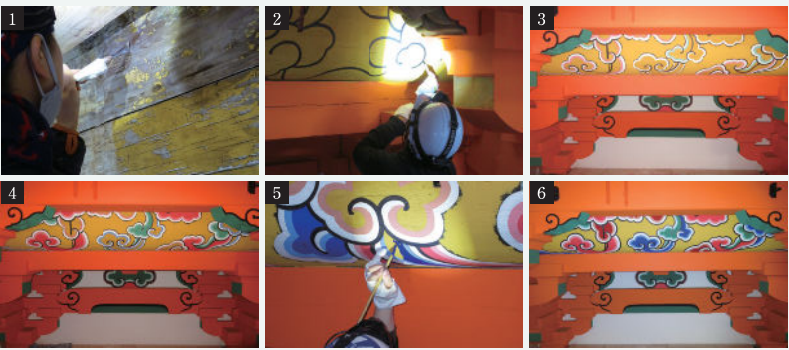
Repainting the itashirin

- 1) Preventing peeling
- 2) After applying yellow background color, clouds are outlined in ink
- 3) After light colors applied
- 4) Deeper colors being applied
- 5) Green and blue are finished by applying mineral pigments
- 6) Itashirin repainting completed

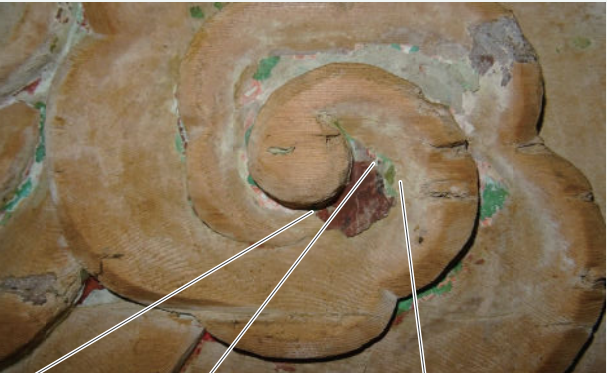
Top layer: Red from *bengara*
Bottom layer: Vermilion from mercury
Middle layer: Green from *ryokusho*

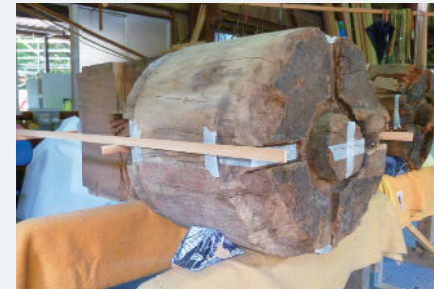
Woodworking process | 01 Removing the rotted sections

One at a time, each pillar was lifted up 6 centimeters off of its foundation using a hydraulic jack. The surrounding structure was also lifted incrementally to prevent the still attached joists from buckling under the strain. Pillar bases have trenches in the shapes of circles or crosses carved into them to allow ventilation. The foundation stones also have ventilation trenches.

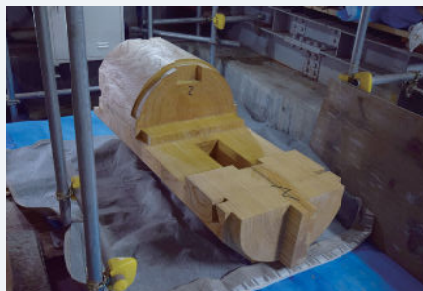
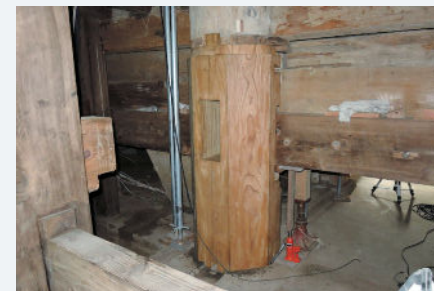
Woodworking process | 02 Connecting the new bottom

The new wood used for the replacements needs to be very strictly inspected to ensure that it is fine-grained and has not developed cracks even when fully dried. Replacing all of the rotted pillar sections took 7 months.

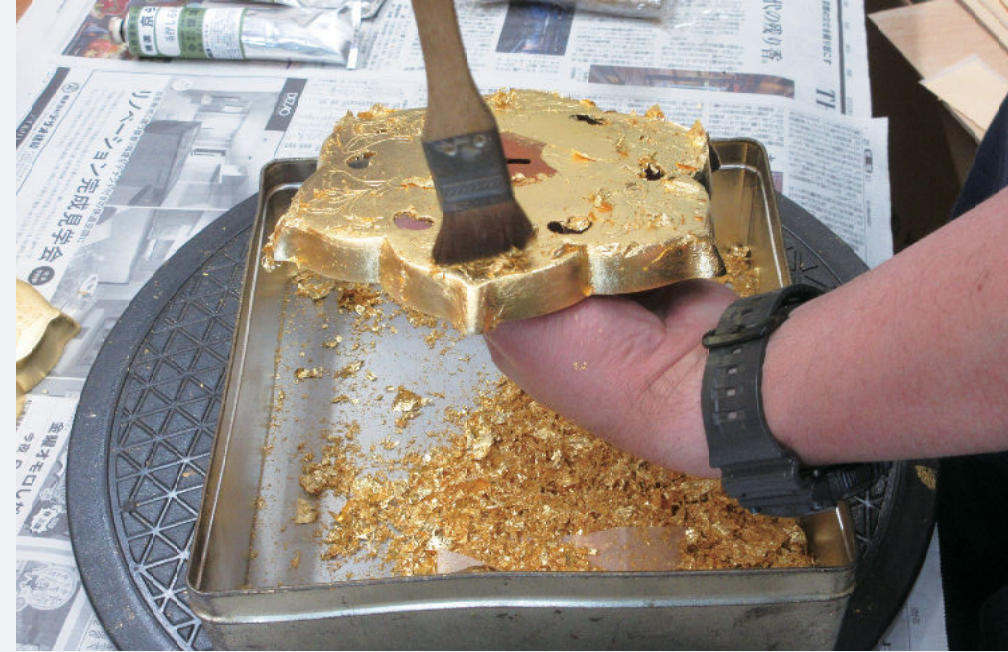
TOP: Fitting before repair
BOTTOM: Fitting after rust removal

Many of the decorative metalwork pieces affixed to the tie beams, doors, and railings of Konpon Chūdō's main hall and outer corridor have been damaged or lost to time. Likewise, much of the gold leaf on the metalwork pieces of exterior of Konpon Chūdō has begun to peel off. As part of the restoration process, the metalwork pieces have been carefully removed from the building, cleaned, re-lacquered, covered with a new layer of gold leaf, and reattached—or, if seriously damaged, replaced entirely.

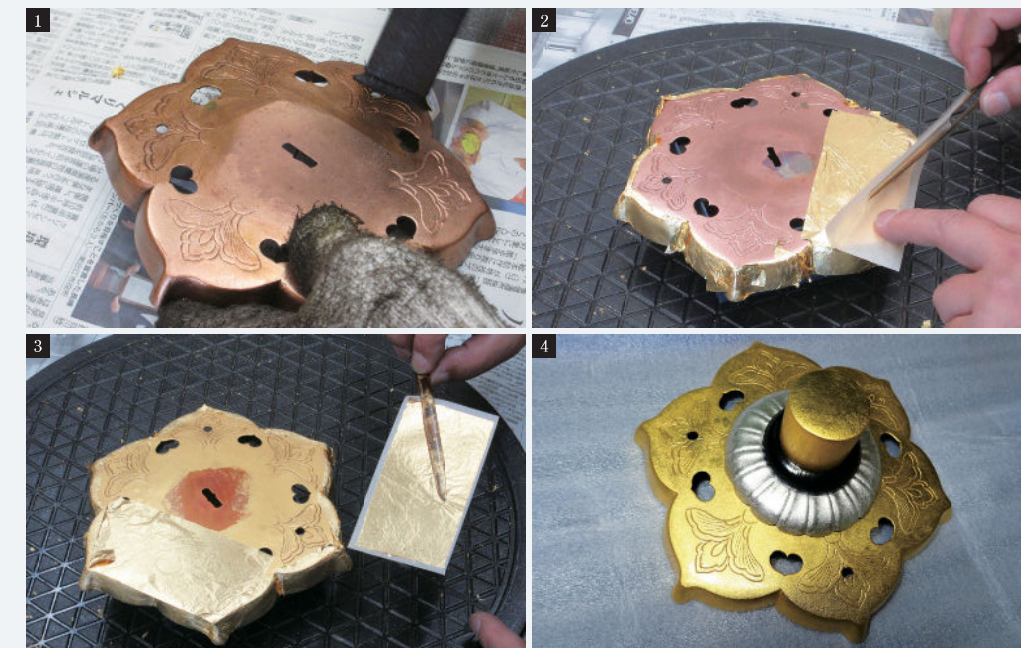
Applying gold leaf

- 1) Lacquer rubbed in to ensure gold leaf adheres. The lacquer blend must be altered based on humidity and work speed.
- 2) Gold leaf is applied. The leaf is only 3 microns thick, so will rip if not picked up along with the paper.
- 3) More lacquer is rubbed in, then the gold leaf is applied. The gold leaf is then brushed to smooth the surface.
- 4) Matched with other parts that have gold or silver leaf applied using this process, or baked lacquer, to complete. Baked lacquer is a technique in which black lacquer is applied to metal fittings, allowed to dry naturally, and then baked at high temperatures.
