(7)琵琶湖における赤潮、アオコの発生状況 赤潮発生の経年状況

ウ 平成20年度 琵琶湖における赤潮・アオコの発生状況

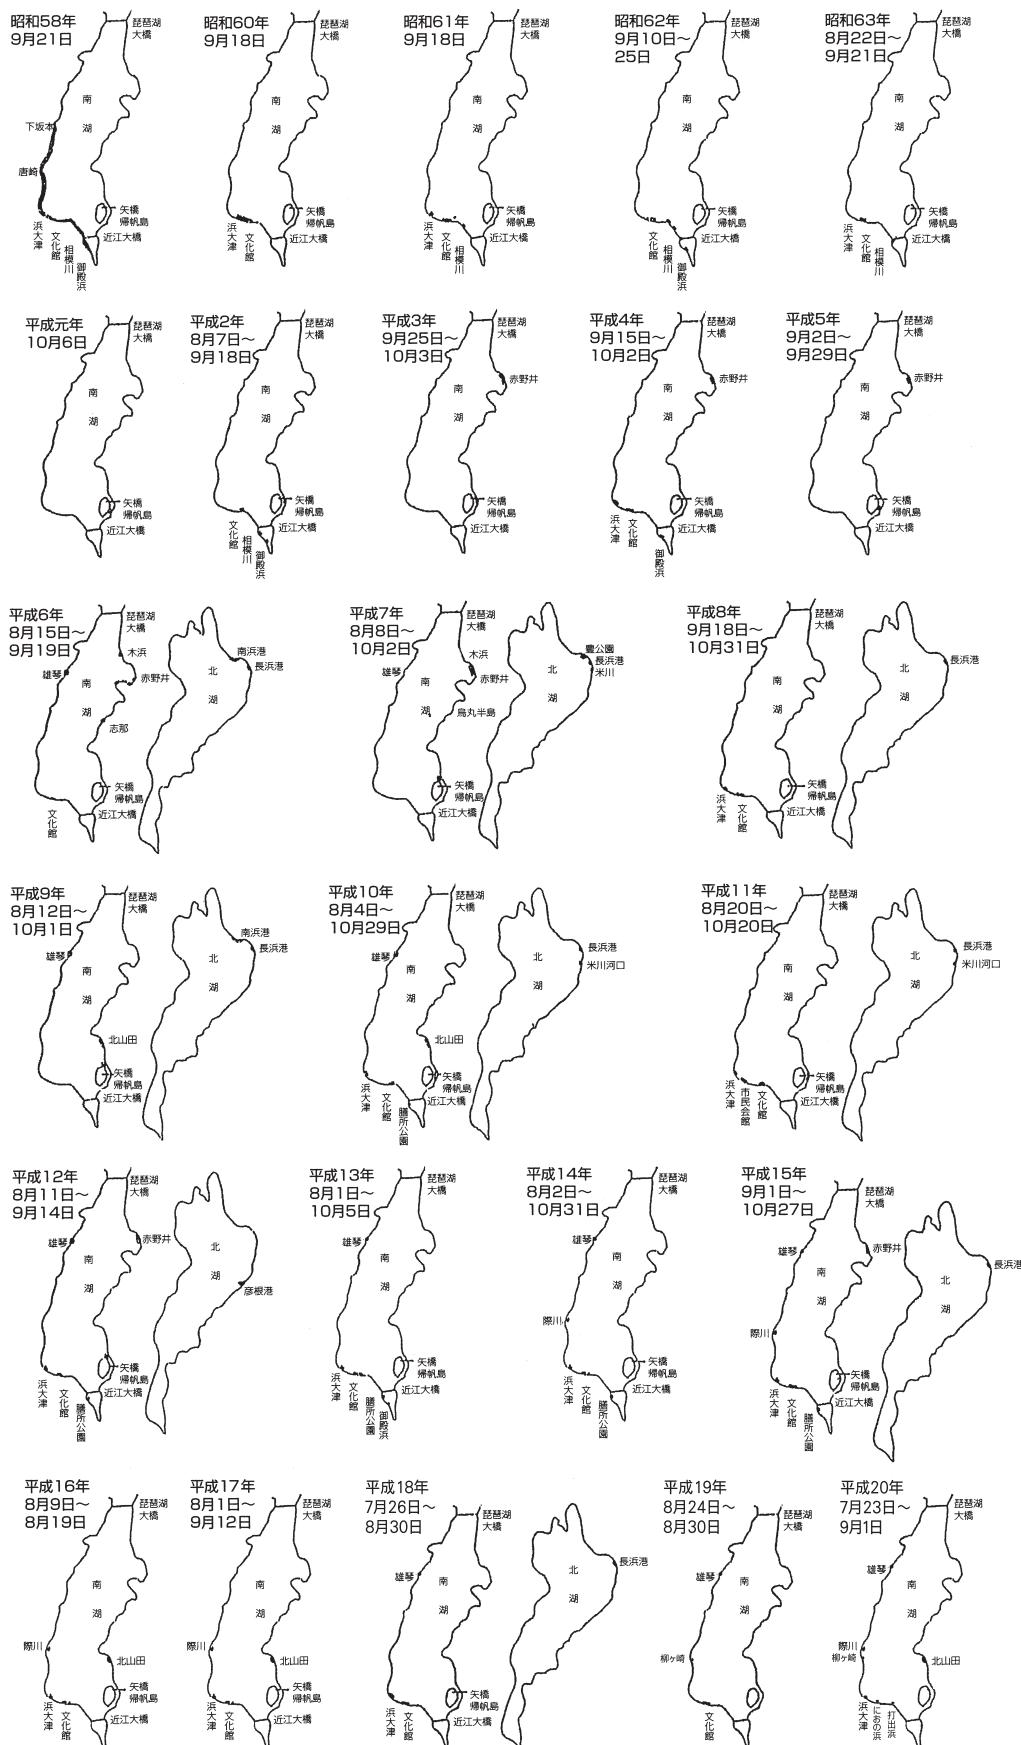
アオコの発生状況

イ アオコ発生の経年状況

年度	月日	23	24	25	26	27	28	29	30	31	1	2	3	4	5	6	7	8	9	10	11	12	13	14	15	16	17	18	19	20	21	22	23	24	25	26	27	28	29	30	31	発生日数	発生水域	延べ水域
昭和58	7																																					1	1水域	1水域				
59																																						0	0水域	0水域				
60																																						1	1水域	1水域				
61																																						1	1水域	1水域				
62																																						13	8水域	24水域				
63																																						16	4水域	20水域				
平成元																																						1	1水域	1水域				
2																																						12	5水域	142水域				
3																																						2	2水域	2水域				
4																																						2	2水域	4水域				
5																																						3	3水域	3水域				
6																																						31	8水域	57水域				
7																																						26	7水域	40水域				
8																																						—	4日	3水域	5水域			
9																																						8	8水域	8水域

10																																						17	10水域	30水域				
11																																						14	6水域	16水域				
12																																						17	6水域	31水域				
13																																						19	5水域	32水域				
14																																						24	6水域	47水域				
15																																						12	7水域	21水域				
16																																						5	4水域	10水域				
17																																						13	8水域	24水域				
18																																						6	4水域	8水域				
19																																						5	3水域	9水域				
20																																						18	7水域	45水域
