# Chapter 4-11

## Water Damage and Flood Control

### Abstract

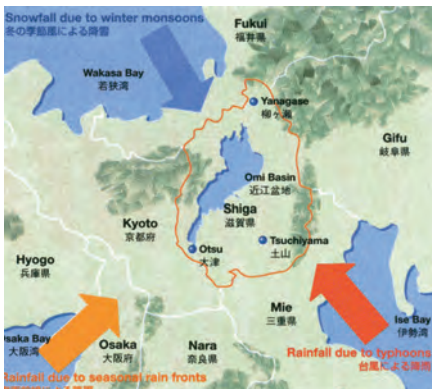
**Fig. 4-11-1** Relationship between topography and atmospheric currents

In addition, because Shiga Prefecture is positioned at the narrowest part of the nation’s main island where Wakasa, Osaka and Ise Bays are located, and is a basin surrounded by mountains in the 1,000 m class, wind directions change depending on the season, producing complex atmospheric currents. For these reasons, rain and snowfall patterns vary from year to year, facilitating the occurrence of localized downpours, resulting in countless past natural disasters such as flooding.

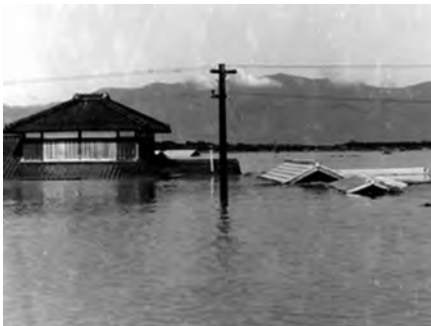
**Fig. 4-11-2** Omihachiman City after the Ise Bay Typhoon of 1959  
(Source: Shiga Prefectural Government River Basin Policy Bureau HP)

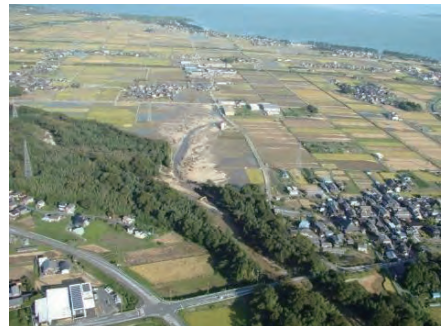
**Fig. 4-11-3** Takashima City after the Typhoon No. 18 in 2013  
Collapses at the Kamo River
